Operational and Economical Advantages Of a New Style Track Switch Heater

Paul F. White
HNTB, Inc.
Chelmsford, MA

Michael K. Fitzgerald
Massachusetts Bay Transportation
Authority
Boston, MA

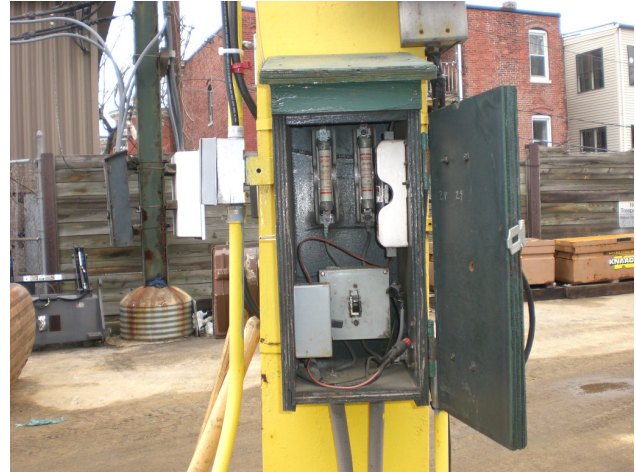
Figure 1. Heater Control Configuration

The positive wire lead from the heater runs in conduit to an overhead wire support pole in close proximity where a controller is mounted. The controller takes 600 volt DC power from the overhead contact system (OCS). Controller types vary but for street switches, it is simply a small wooden or fiberglass enclosure with a fuse and a

snap switch to open the circuit and shut off the heater (Figure 1). Conduit is typically one inch PVC. The negative wire lead is long enough to extend to the switch casting joint where it is attached to a rail bond with a split bolt connector or wrapped around a track bolt. Figure 2 shows a typical open switch heater with positive and negative connections.

The Tubular Element style heater in use at the Authority was directly embedded in the pavement next to the switch casting containing the moveable switch point and covered over with excavated earth and then paved over. The positive wire connection of the heater was connected to a another wire that ran to the switch controller where a connection was made to a positive 600 volt attachment at the trolley wire (also referred to as catenary or overhead contact system with OCS as its acronym). The negative lead of the heater was connected to a rail bond or track bolt on the track switch casting at the rail joint as shown on Figure 1.

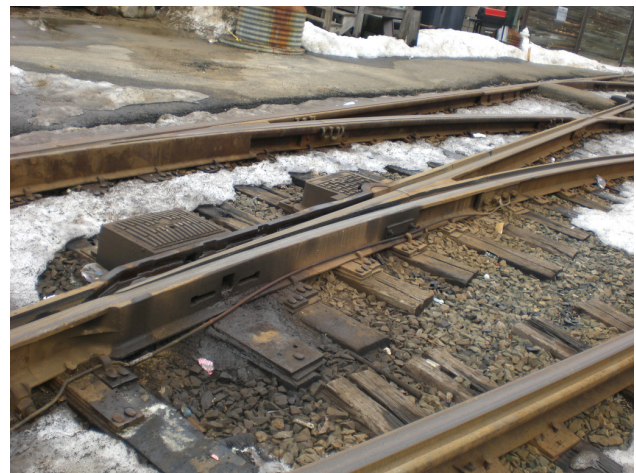
Figure 2. Heater Installation for Open Switch

Heaters are laid next to the side of the point casting in a loose fashion as no clips are used. For open faced switches, parts of the heater contact the casting and the high wattage is sufficient to transfer enough heat to the casting and point to keep it clear of snow or ice. When the heater is installed in pavement, the heat produced is also successfully transferred to the switch.

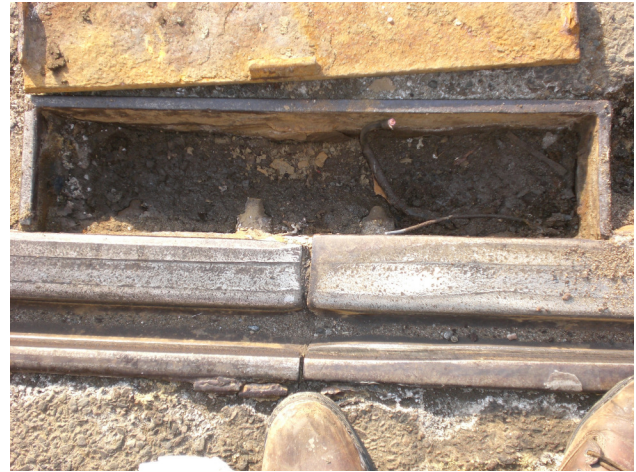
Figure 3. Pipe/Joint Box Configuration

The next design that was considered utilized a one inch pipe with access boxes at each end so that a failed heater could be withdrawn and a new heater installed without excavating the pavement. Heater types could be such that they had insulated ends with a neutral sheath (in that it was not connected to the negative wire lead) as the pipe had consistent diameter allowing large terminals to be drawn through. The access boxes were fabricated with standard girder rail joint bars and welded with sides in such a manner that a cover could be placed onto it that would lie flush with the top of rail and the pavement. The bottom was omitted for drainage. One box was installed at the switch casting joint and a mirror image box at the opposite joint with a hole in the side wall for the pipe to be inserted.

The joint boxes were actually the joint bars for the casting and attachment rails and allowed the track bolt to be inserted from the other side of the rail and nutted inside the joint box. The pipe was tack welded to the casting and the dirt box altered to allow the pipe to fit through. With or without a heater, the switch operated properly and safely with the joint boxes and pipe attached. The steel used for the joint box was standard A36 plate steel non-galvanized and extra heavy black pipe. Due to the requirement of welding on the switch casting, galvanizing was not used. Figure 3 shows the joint box attached to the rail joint with open cover.

When installed, the pipe/joint box installation worked very well and heaters could be installed in paved areas quickly and removed quickly if failure occurred. At the Boston College terminal and yard, all of the paved switches at the yard entrance (total of 8) were equipped with the pipe/ joint box heaters and remained in service

The pipe system initially worked without incident but as time progressed, the corrosion from water combined with road salts attacked the pipes and joint boxes and saturated water with salts drained into the pipes causing

sheath corrosion and failure. As heaters failed during storms and cold weather, the water froze in the pipes making simple removal impossible. Road dirt also drained into the joint boxes and pipes and coupled with water became almost like concrete when frozen. Failed heaters had to remain in the pipe and the pavement excavated so that a new heater could be laid in near the surface of the street. Continued corrosion of the pipes rendered the installations unusable so that the pipe system was abandoned and the former direct bury system was continued.

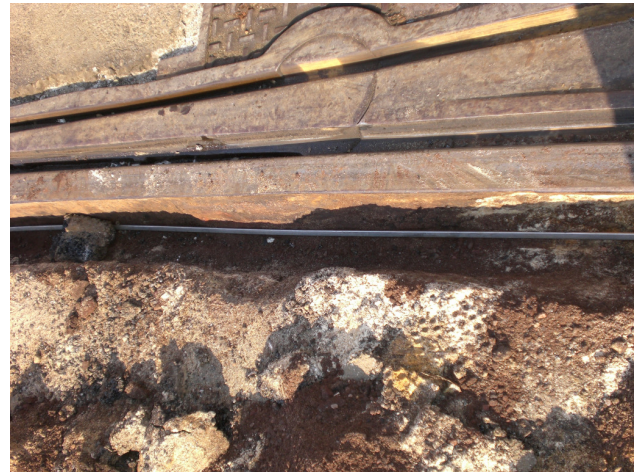
Figure 4. New Style Heater Installed

The heater has a flat configuration in that it lies against the side of the point casting providing more surface contact. The increase in contact areas compensates for the reduced wattage and power consumption without sacrificing heating efficiency. A clip on spring clip keeps the heater positioned tight against the rail for new installations insuring heat transfer is accomplished as efficiently as possible. For replacement of existing heaters, the area next to the switch casting is

excavated and the new heater layed in next to the casting near the top and then back filled and paved over (Figure 4). The heater is able to pass behind the dirt box in the same recess as the old style heater (Figure 5).

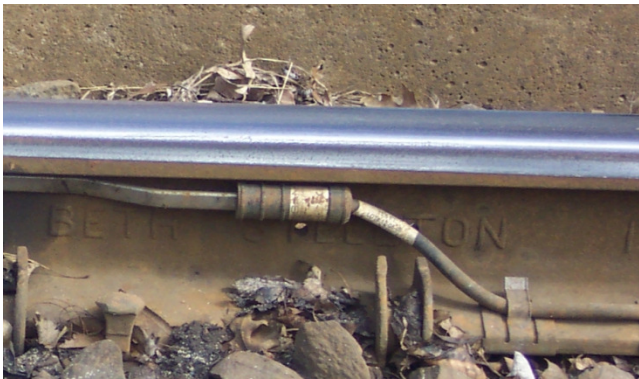
Figure 6. New Style Heater Terminal

The heating element itself is resistive and of constant wattage with only one terminal where the positive negative lead wires are connected to their respective wire leads (Figure 6). This initially was of concern to the Authority as all existing heaters are designed with two terminals, a positive on one end and the negative on the other end. Re-wiring the heaters at each track switch would be required but if the trials proved successful, this was a minor inconvenience.
